EXHIBIT 5 (PART 2 OF 2)

2.5.3 Cabinet Interior

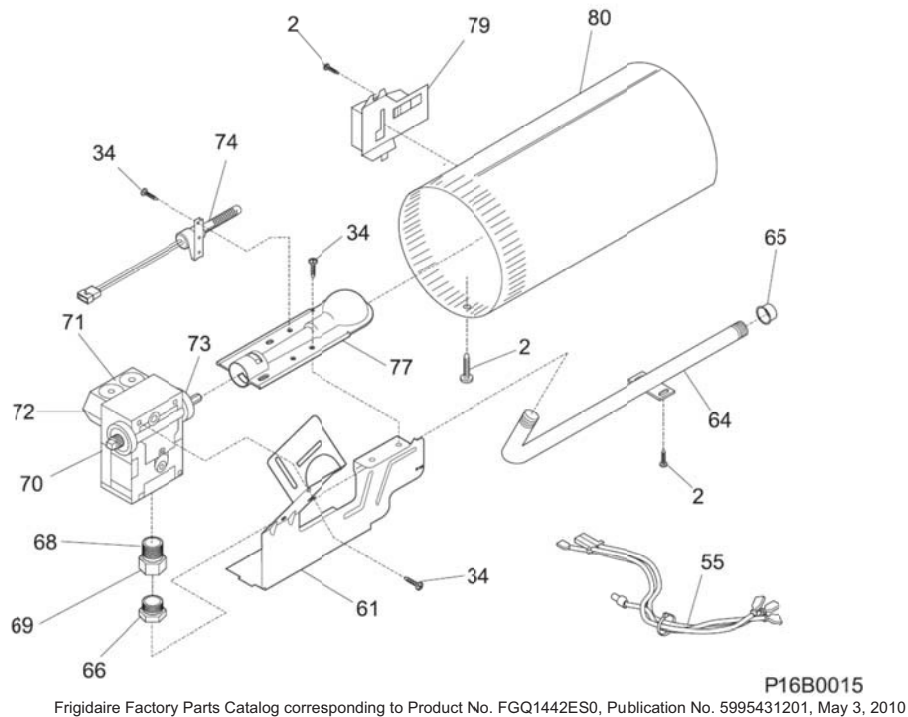
Figure 4. Example “ice-cream scoop” style gas burner system from a Frigidaire Factory Parts Catalog corresponding to Model Number FGQ144ES0 gas heated dryer.

The gas flow is controlled by a gas valve assembly (components 70-73 in Figure 4). A representative diagram of the gas valve assembly is shown in Figure 5, which consists of three primary components: a pressure regulator, a primary (or booster) coil and a secondary coil. The pressure regulator is typically preset for natural gas, and the regulator adjustment screw is changed to match the pressure for LP service. The regulator dictates the gas pressure, and the coils (or solenoids) control whether the gas can flow into the combustion chamber. If the coils are energized, gas can flow out of the orifice and into the burner (component 77 in Figure 4). In the burner, the air flows past an air shutter and toward the hot surface igniter (component 74 in Figure 4). The air shutter allows air to mix with the gas prior to ignition. Proof of ignition is monitored by a radiant sensor mounted at the side of the combustion chamber (component 79 in Figure 4).

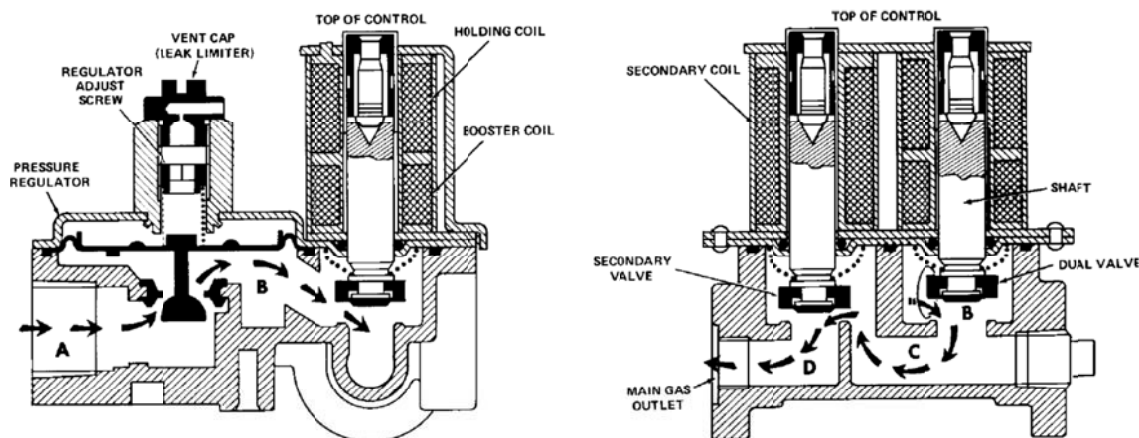
Figure 5. Diagrams indicating principle of operation for gas valve in the clothes dryer.

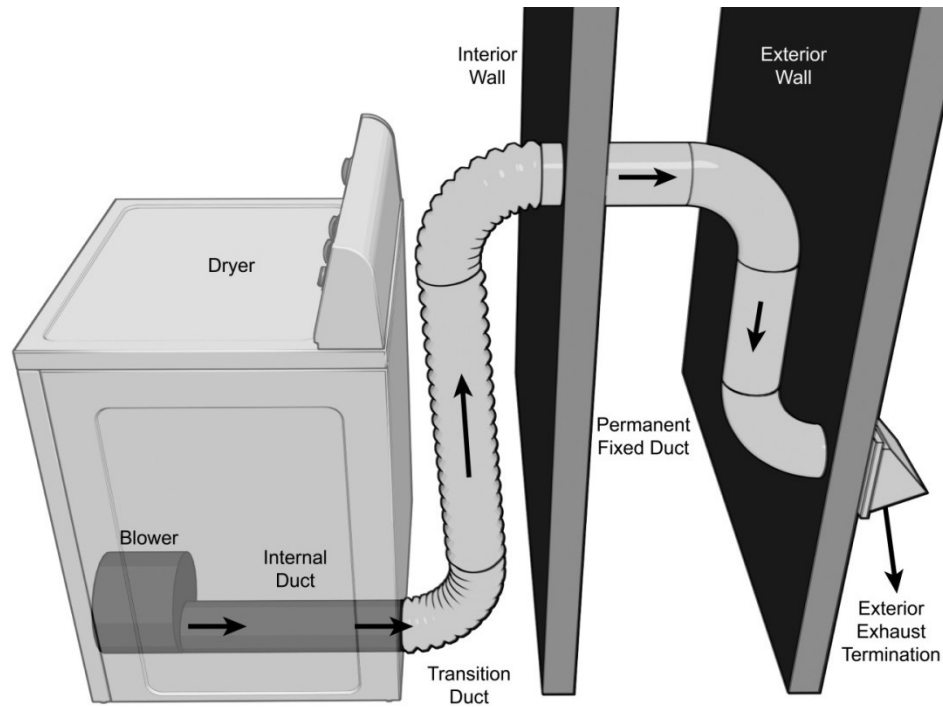
A clothes dryer exhaust system consists of three distinct sub-systems: the manufactured internal ducting and blower, the external transition duct between the clothes dryer and the permanent exhaust ducting, and the permanent exhaust ducting in the home. Figure 6 below illustrates the flow of air from a generic clothes dryer through the exhaust system. The exhaust system is intended to convey warm, humid air and residual lint particles out of the clothes dryer and out of the residence. A blocked or restricted exhaust system will prevent normal operation of a clothes dryer, can cause overheating of the unit, and may lead to accelerated lint accumulation inside the dryer.

Figure 6. Schematic of a typical clothes dryer exhaust system.

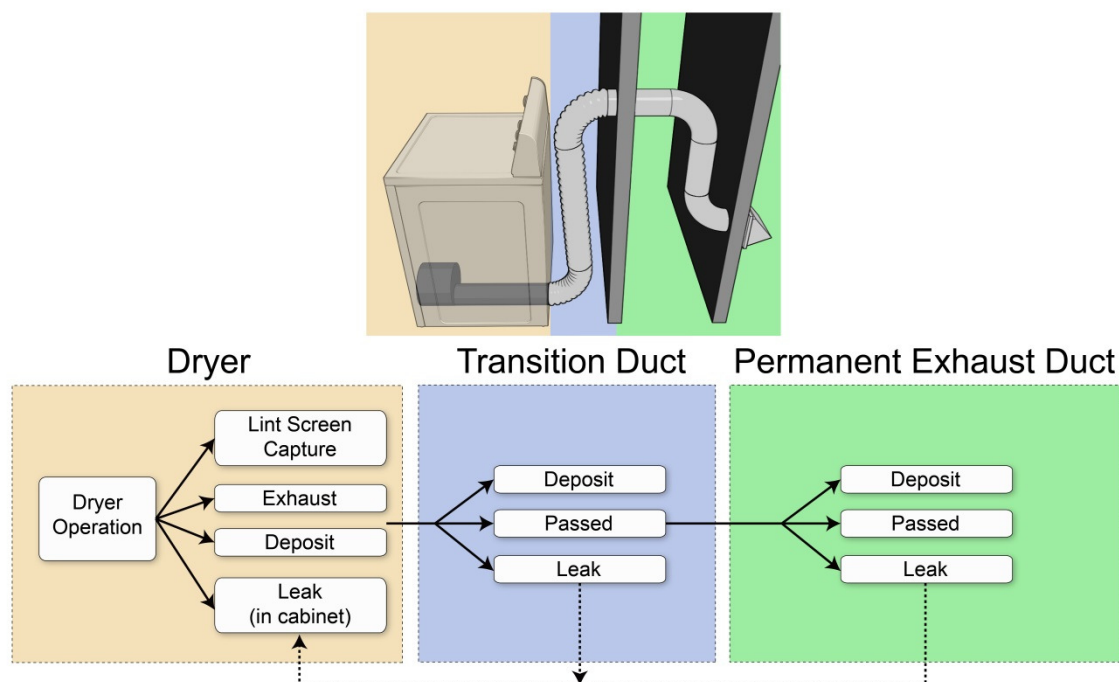
During normal operation, lint particles travel with the exhaust air stream. In the exhaust ducting, the lint particles will be captured—either intentionally on a lint screen or deposited unintentionally such as on a sharp edge, will leak out of the exhaust ducting, or will be passed through the system. Figure 7 below outlines the mass flow for clothes dryer lint from its origins during clothes dryer operation through the entire exhaust system. In each section of the system, lint may leak out, pass through, or be captured or deposited. The lint deposited within the clothes dryer cabinet will likely remain there and continue to accumulate until it is cleaned by an authorized service technician. However, lint that is leaked from the transition or permanent duct has the potential to accumulate outside the clothes dryer or be pulled back into the clothes dryer with make-up air, thus increasing the opportunity for accumulation within the clothes dryer cabinet. Deposited lint within the exhaust system can restrict or block airflow within the venting system.

Figure 7. Mass flow material balance for clothes dryer lint.

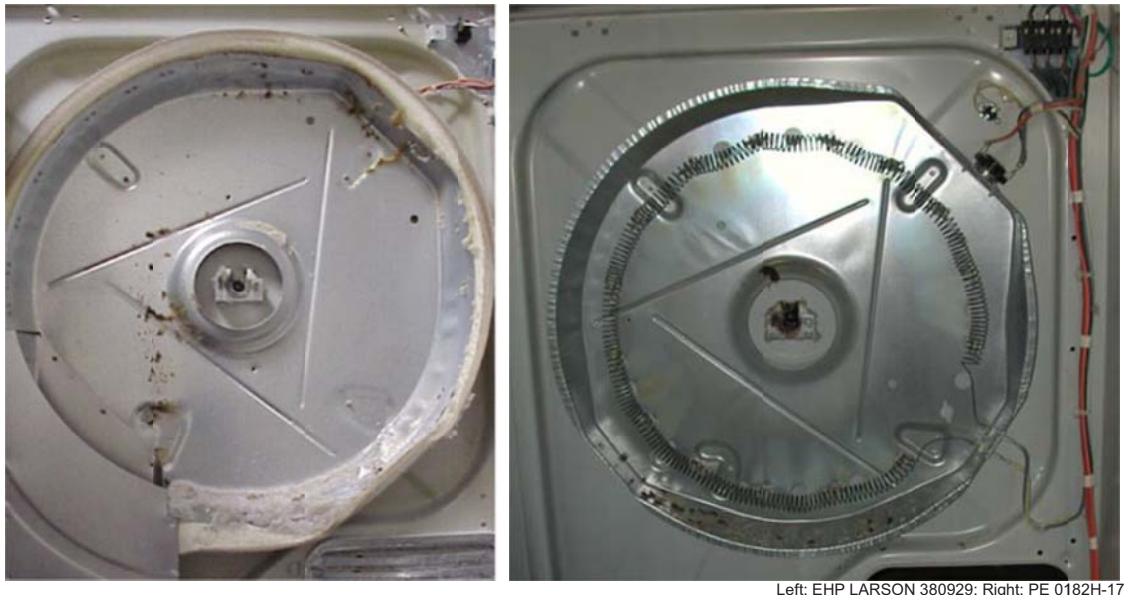
Left: EHP LARSON 380929; Right: PE 0182H-17

I conducted a study of 10 Electrolux electrically-heated clothes dryers that had been operated identically for several months in the Electrolux accelerated life testing laboratory.³⁷ No significant amounts of lint accumulated near the heating element in the pan in these clothes dryers. (Figure 9 is a photograph of the thermally-degraded lint deposits in the heater pan from a 2002 manufactured electrically-heated clothes dryer.) None of these units had significant lint accumulations in the space between the baffle ring and the back of the drum either. Lint did accumulate to a varied extent within the cabinet and within the plastic air duct, but this lint was not near likely potential ignition sources. Electrolux also provided a photograph of a gas-heated

dryer (left in Figure 9) that had been operated for 5000 cycles in the 2004-2005 Japanese claims investigations file. This heater pan shows a small lint deposit at the 6 o'clock position, which is not thermally degraded.

Figure 9. Example of lint accumulation in the heater pan for: (left) a gas-heated dryer operated for 5000 cycles with the maximum recommended backpressure (circa March 2005) and (right) an electrically-heated dryer (Model FER211AS1, Serial No. XD22107877, 73 continuous days/3.48 years of operation with a load, 146 days/7.3 years of operation without a load).

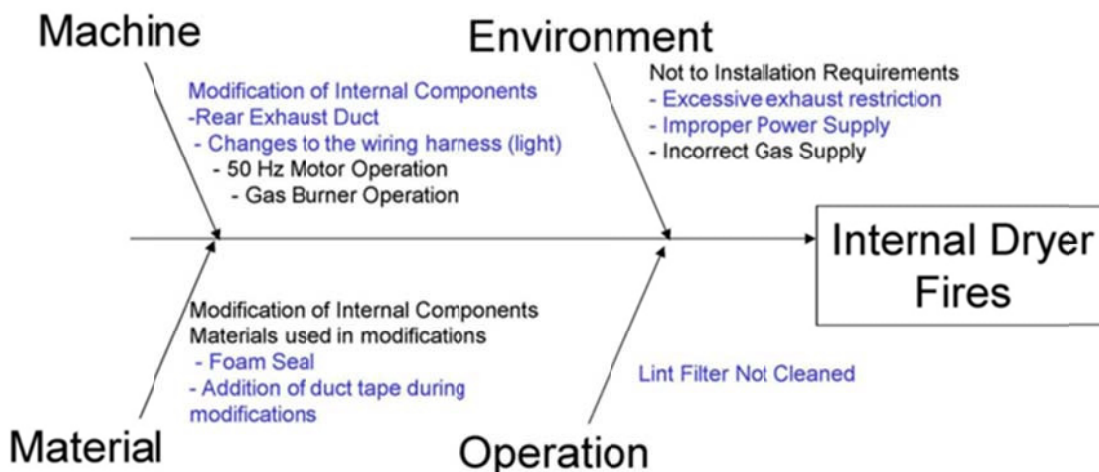
From EHP LARSON 380690

Figure 11. Example Ishikawa diagram created by Electrolux during root cause analysis of the Japanese clothes dryer fires circa 2005.

As a result of this investigation, Electrolux identified several corrective actions for their Japanese distributor and Japanese authorities to eliminate these root causes. The recommended corrective actions for the Japanese gas-heated dryers were to inspect and clean field units, add a thermal fuse, replace the gas orifice in all products in Japan and to measure, and correct if required, the exhaust system restriction.^{67,68,69} The change in the gas orifice served to reduce the fuel gas flow rate thereby correcting for the gas supply differences (heating value) between United States and Japan. This is analogous to converting an appliance from natural gas to propane which was briefly discussed in Section 2.1.2.

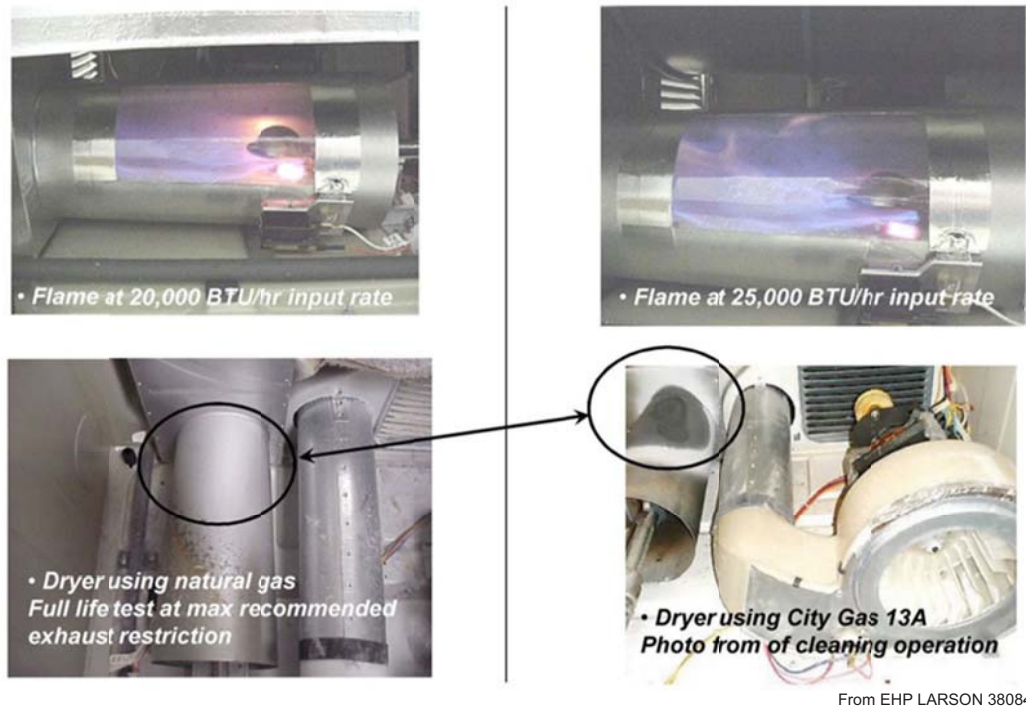
1. Modifications of the Dryer unknown to Electrolux
 - a. Removal of the rigid metal exhaust tube and rubber seal, replaced by a flexible metal tube and plastic duct tape;
 - b. Modification of the wiring harness with the addition of terminations to the two control thermostats and the addition of a light to the console; and
 - c. The introduction of combustible materials inside the dryer cabinet.
2. Installation anomalies
 - a. Japan's electrical supply of 100V at 50Hz and 60Hz is below the specified power supply of 120V at 60Hz, and that
 - b. The documented large amounts of lint accumulation inside the dryer cabinet were most likely a result of excessive exhaust restriction.
 - c. Improper gas supply: Japanese natural gas supply results in a 25% increase in burner heat output (BTU/hr) and larger flame compared to the US natural gas supply (see Figure 12).

Figure 12. Comparison of the effects of heat input from fuel gas. The burner system is rated for 20,000 BTU/hr (left). A higher heat input causes a larger flame that fills more of the combustion chamber.

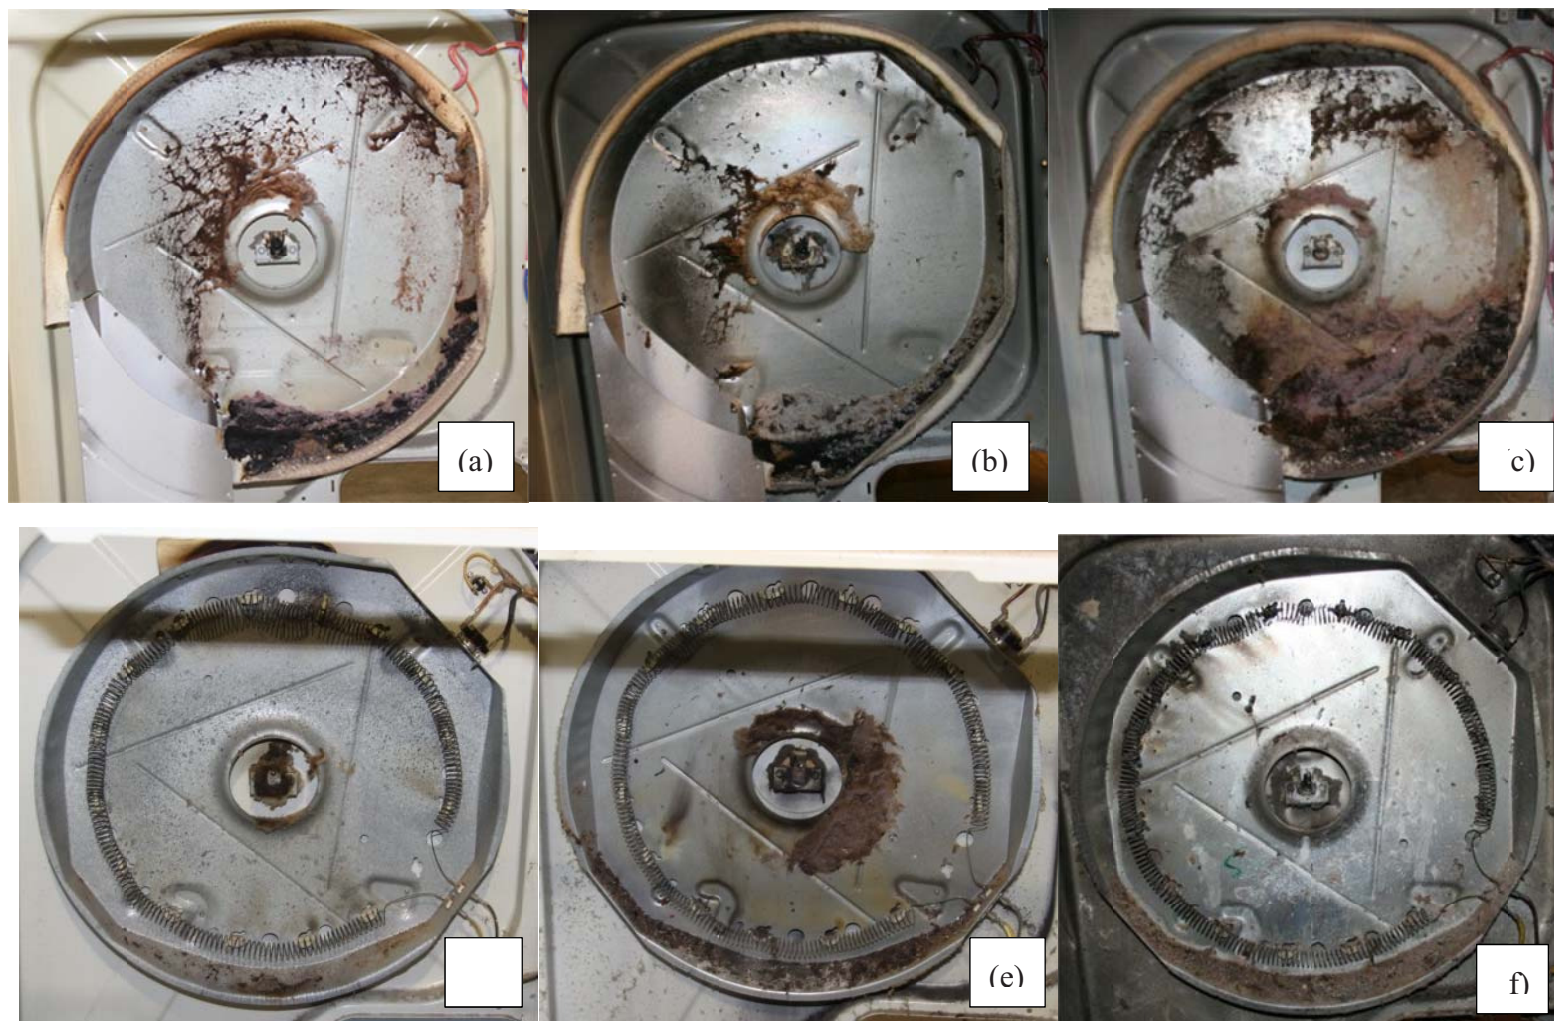
between the two types of heater pans. Figure 13 depicts six examples of lint accumulation in heater pans that I retrieved from the hard drive provided by the Wright Group. I selected these images because it was apparent that the lint deposits were not degraded by a fire inside the clothes dryer cabinet or drum. Thus, these images support the difference in dynamics of lint accumulation, when it occurs, in the heater pans of the two types of dryers.

Representative gas heater pans (the top three images a-c in Figure 13) demonstrate lint deposits on the vertical back wall and outer circumference of the heater pan. Although I have not found any comprehensive studies that clearly detail the physical processes involved, I can infer based on my education and experience what physical processes are dominant in this system. These deposit patterns are indicative of particulates traveling into the heater pan with the incoming air through the combustion chamber. If the burner is firing, incoming airborne lint particulates will be vaporized without flaming. Deposits do not accumulate on the left side of the pan where the high temperature incoming air stream is too hot to allow the deposits to exist. The adhesion of lint to the back wall of the heater pan is likely due to high moisture levels in the incoming air when the burner is not firing that would be caused by inadequate ventilation of the dryer. Growth of lint deposits will be enhanced by high moisture levels in the air stream and lint-lint particle cohesive forces. The lint deposits collected in the bottom of the heater pan are due to particle impaction and settling against the bottom wall of the heater pan. The airflow has to also turn to move axially through the back wall of the drum, which can allow particle settling in the bottom of the heater pan to occur if the overall airflow velocity is too low to carry all of the particles into the drum.

Representative electric heater pans (the bottom three images d-f) demonstrate lint deposits that are significantly different from those in the gas heater pans (the top three images a-c). From my review of the Wright Group hard drive and experience in evaluating other Electrolux-manufactured clothes dryer fire incidents, the depicted types of deposits are representative of the type of lint accumulation possible in the electric heater pan. The lint deposits observed in heater pans d and f are very similar to the deposits I observed in my review of 10 accelerated life tested electrically-heated Electrolux dryers.⁷¹ The airflow into the electric heater pan is much different since it enters radially around the perimeter of the heater pan and axially through holes in the back wall of the heater pan. Where airflow into the gas heater pan is tangential to the heater pan, centrifugal forces have an effect on lint deposition. In contrast, the radial and axial flow through the electric heater pan is not as likely to allow lint deposits to accumulate in the heater pan.

Figure 13. Examples from Wright Group drive of lint accumulation in heater pans for gas-heated and electrically-heated dryers.

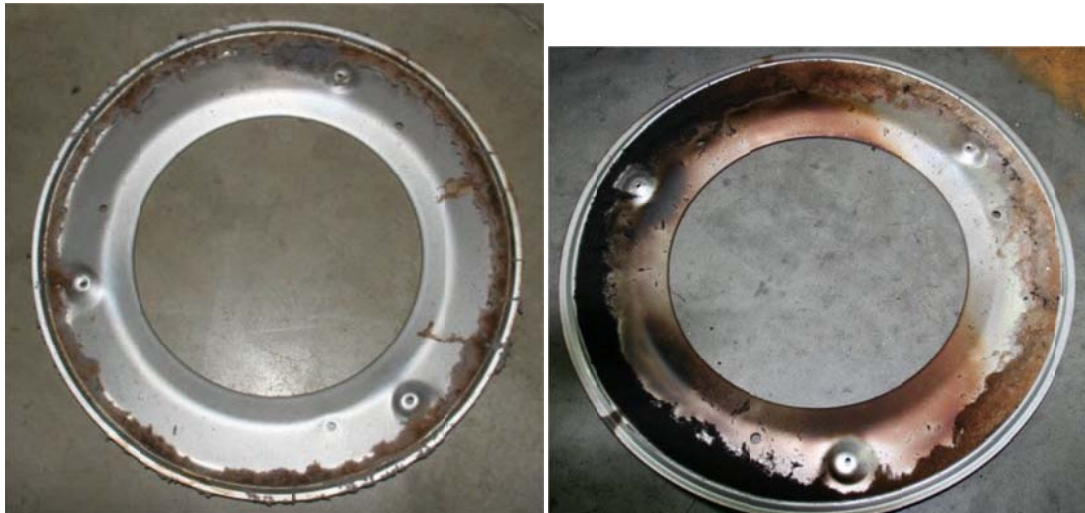
I have also observed that some, not all, dryers with lint accumulation in their heater pan have lint accumulated in the area between the baffle and the back wall of the drum. This lint is readily visible from the drum opening when looking at the rear wall of the drum. Figure 14 depicts two examples of lint deposits in this area. In contrast, I found no significant lint accumulation in this area when I studied the lint deposition in 10 clothes dryers that were tested in a controlled setting.⁷² From examination of the deposits in several clothes dryers, I found that this type of deposit is sandwiched between the rear wall of the drum and the baffle ring. As a consequence when the baffle is removed, the restraint provided by the drum and baffle ring is removed and lint deposits are pulled from the drum wall. Previously adhered and stationary lint deposits can then appear to be loose within the baffle.

Figure 14. Examples of lint deposits in baffle rings.

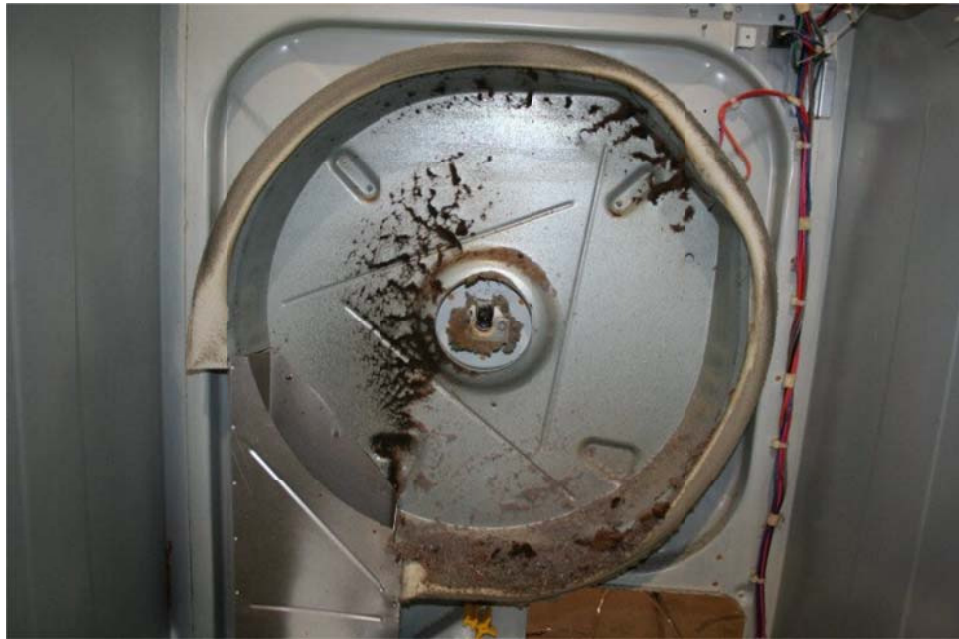
Page 43 of 550 in "1 Photos_lint accumulation Electrolux gas Used_may 2011.pdf"

The test involving the used 2000 Frigidaire Model FDG648GHS0 (S/N XD01904902) demonstrated the most dramatic lint accumulation and apparently experienced a thermal event between test cycle 10 and 20. This dryer was received in the used state and contained lint deposits in the base and in the heater pan. The lint in the heater pan was deposited on the left side of the back wall of the heater pan in a radial fan pattern, on the top outer edge of the pan, around the bearing hitch in the center, and in the bottom of the heater pan. Figure 15 is a photograph from the Wright Group hard drive.⁷⁴ The lint on the left side of the pan that continues in the fan around to the 2 o'clock position is darkened and discolored due to thermal

degradation from high temperature exposure. The lint that has deposited in the center of the pan around the hitch and in the base of the pan is gray and does not appear to be discolored. This non-discolored appearance is consistent with cooling of the air stream due to additional fresh, cooler air from the cabinet entering the heater pan through the bearing opening. Some larger chunks of lint appear to have fallen on top of the non-thermally degraded lint at the bottom of the pan as a result of transport, not operation of the dryer. If these deposits fell into this location during operation prior to transport, they would likely be covered with non-thermally degraded lint, but they are not. The duration of exposure of the discolored lint to high temperature air cannot be determined from looking at the lint. It may have been due to a few cycles or it could be evidence of prolonged poor ventilation effects.

Figure 15. Pre-test image of the heater pan from the used dryer 2000 Frigidaire Model FDG648GHS0 (S/N XD01904902).

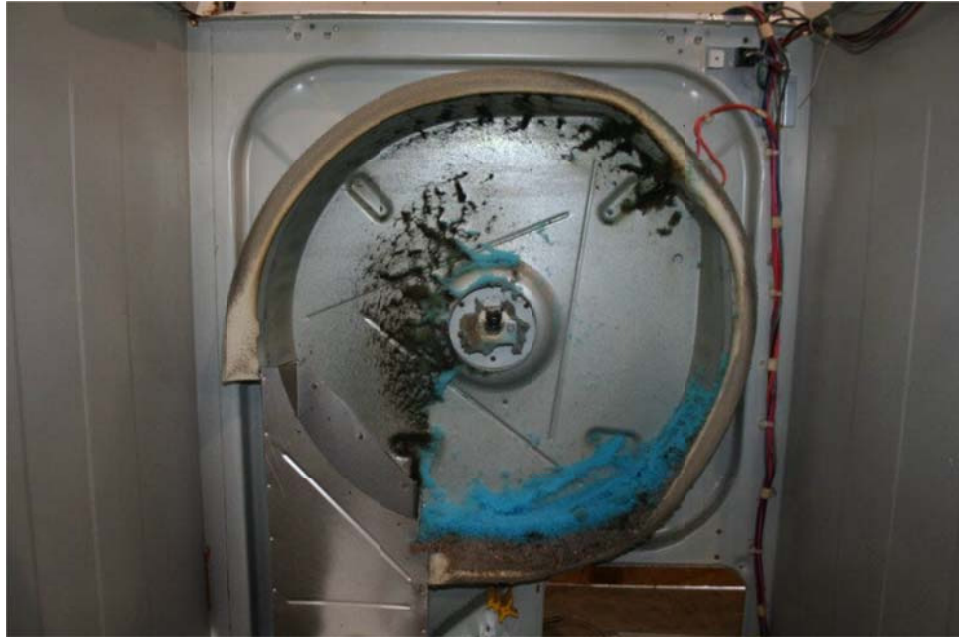
Page 263 of 550 in "1 Photos_lint accumulation Electrolux gas Used_may 2011.pdf"

The test photographs indicate that the test process has significantly increased the rate of lint accumulation in the heater pan. This dryer was 11 years old (manufactured in May 2000 and tests conducted in May 2011) at the time of the testing. The prior installation, operational history, and maintenance history were not reported. However, the heater pan contained some lint accumulation from its life of use. Since the dryer airflow performance was not characterized prior to the start of their testing in 2011, I cannot refute the hypothesis that the Wright Group's manipulation of the dryer (i.e., disassembly, modification, and reassembly) created leaks that were not previously present in the dryer system. As depicted in Figure 16, after 10 cycles with the large, new blue cotton towel load, the quantity of lint that had accumulated in the heater pan was disproportionately much greater than that present from the prior life of the dryer. The thermally-degraded lint accumulation on the vertical, left surface of the heater pan has significantly increased along with the non-thermally degraded lint in the bottom of the pan. This disparity is an indication that the combination of ventilation change, disassembly/ reassembly process, and drum load may all have played a role in the test outcome. The other new, unused dryers do not have such a comparison base since they were new.

Figure 16. Image of the heater pan from the used dryer 2000 Frigidaire Model FDG648GHS0 (S/N XD01904902) after 10 drying cycles with a large 12-pound load of new, unused cotton towels.

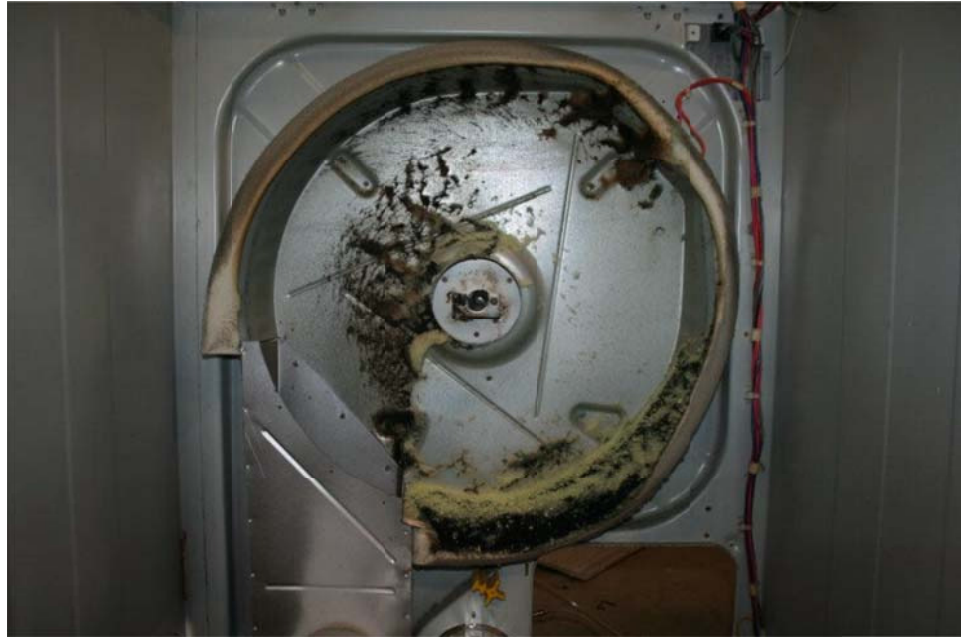
Page 465 of 557 in Appendix B.pdf

This dryer then displayed evidence of high temperature in the heater pan that occurred between cycle 10 and cycle 20. The blue towels were replaced with new, unused yellow towels. The top surface of the accumulated lint in the bottom of the heater pan was blackened and thermally degraded with a top coating of non-degraded yellow lint as depicted in Figure 17. The plastic bearing support was also melted and blackened. From these photos, it is apparent that the air temperature in the heater pan was significantly higher than previous cycles for some period of time during cycles 11 to 20. Mr. Parsons of the Wright Group testified in the Power matter that he believed that this test was evidence of the fire cause scenario based on the blackened lint in the heater pan.⁷⁵ He testified that about five minutes into the cycle, he and Mr. Stoddard were in the laboratory area and heard an unusual, loud noise. They investigated and did not identify any external signs of an issue with the test dryer such as smoke or other noises. After the test, he believed that this noise was evidence of the ignition event.

Figure 17. Image of the heater pan from the used dryer 2000 Frigidaire Model FDG648GHS0 (S/N XD01904902) after 10 drying cycles with a large 12-pound load of new, unused cotton towels.

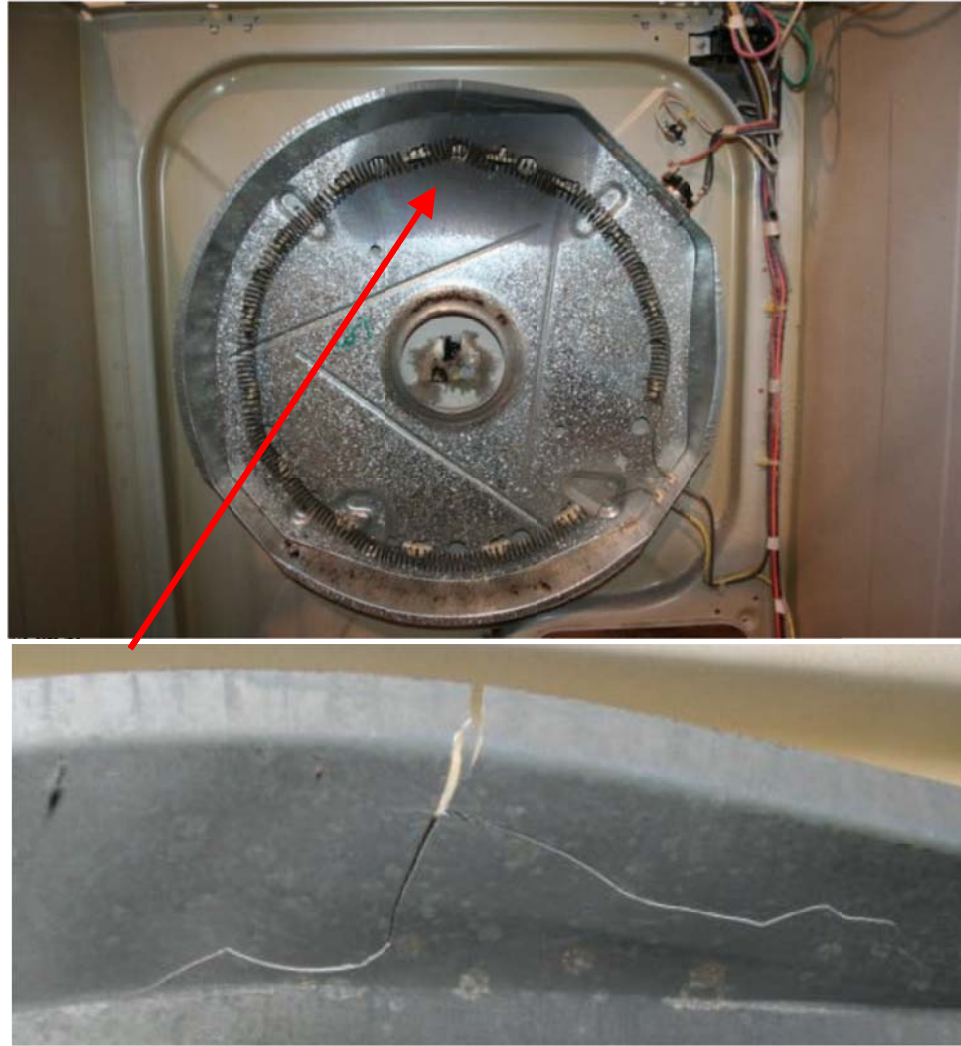
The fire set in the testing by the Wright Group titled "WGI Electrolux burn tests 09-14-2007" involved a used electrically-heated dryer with a sagged heating element and a damaged heater pan as shown in Figure 18. This test was documented through a series of pre-test and post-test photographs and an external video.

The dryer was a Model GLER331AS1, Serial No. XD241017123, which was five years old at the time of the test. The prior history of the dryer was not documented. The initial appearance of the heater pan is consistent with inadequate airflow causing a local high-temperature region at the top of the heating element, which discolored the heater pan. This high-temperature exposure apparently led to a fracture in the top of the heater pan housing. The heater pan and baffle had insignificant quantities of lint, which would not pose a fire risk. However, the excessive accumulations of lint inside the cabinet, in the exhaust tube, and on the outside of the inlet air grill indicate that the dryer likely had restricted exhaust, which caused lint leakage outside the appliance. The observations support the conclusion that high temperature at the top of the heater pan was likely caused by restricted venting; however, there was no significant lint accumulation in the heater pan or baffle.

Figure 18. Heater pan used in the Wright Group Electrolux burn test 09-14-2007 with sagged heating coil and cracked heater pan.

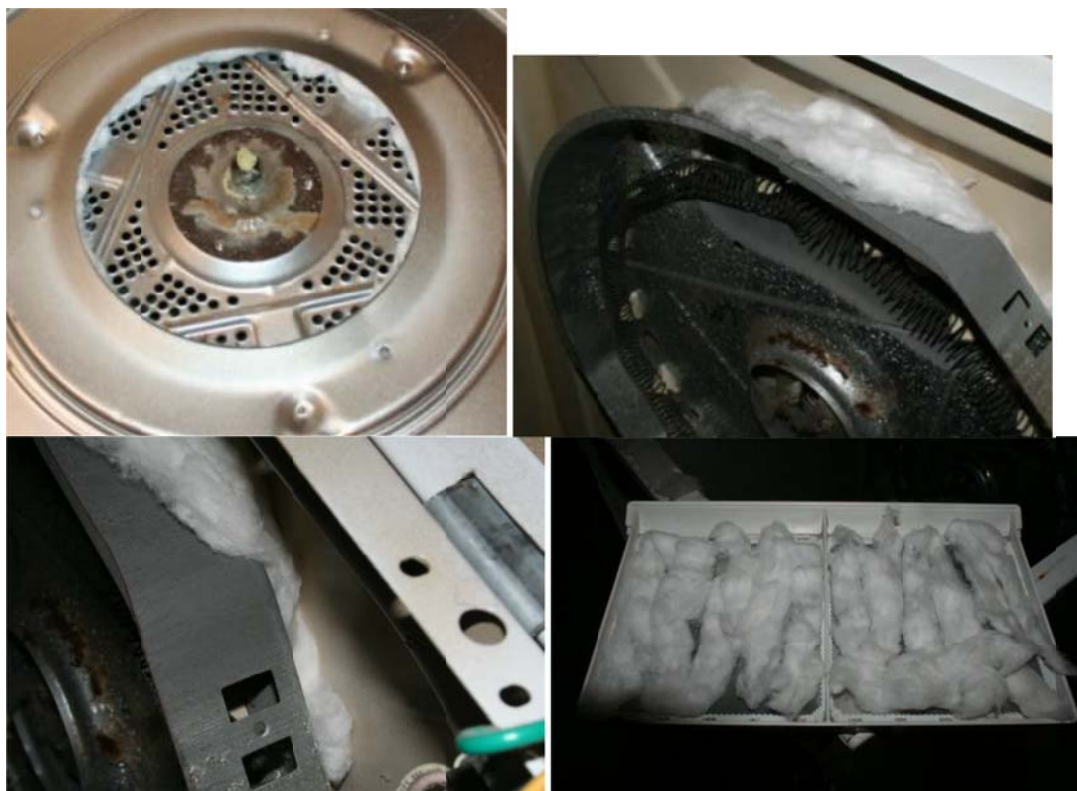
Although the heater pan did not contain any lint accumulation before the test, the air duct and base of the dryer had significant lint accumulations. For the test, the Wright Group packed the baffle, top side and behind the top of the heater pan, and lint screen with cotton balls as shown in Figure 19. I have not seen a similar accumulation or evidence of a burned accumulation of lint in any of the dryers or discovery documents that I have reviewed; thus, I could not confirm their basis for placement behind the top of the heater pan. The dryer drum was loaded with dry bath towels and operated during the test.

Figure 19. Cotton locations.

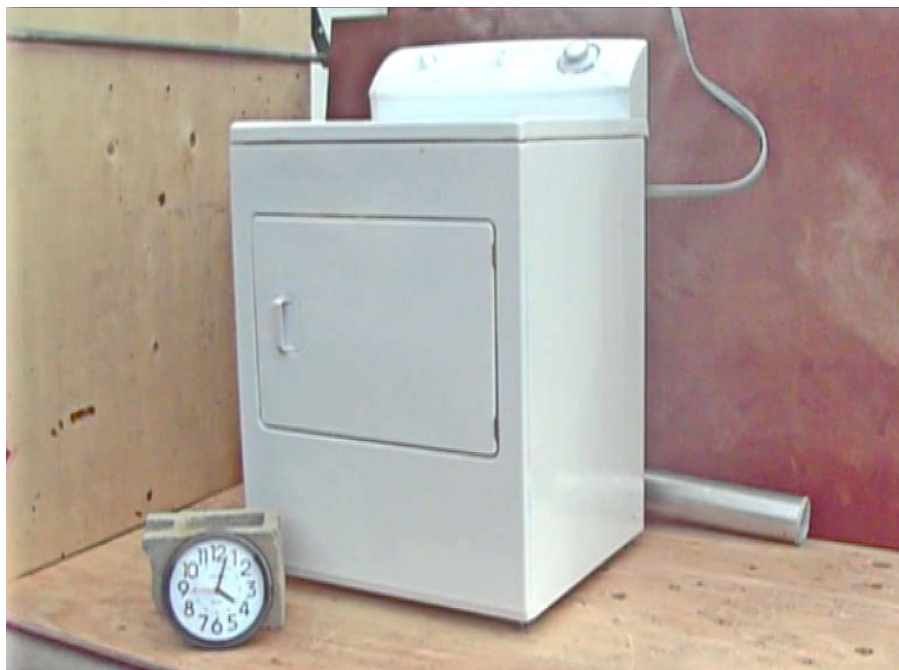
Approximately seven and a half minutes after the dryer was started, smoke was observed blowing out of the exterior exhaust duct. Approximately two minutes later, smoke ceased to flow out of the exhaust and instead appeared out of the top of the control console, the dryer door, and the corners of the dryer as shown in Figure 20. Since the smoke was no longer being blown out of the exhaust duct, either the motor was de-energized or the blower was damaged. No external evidence of electrical shorting was observed.

Figure 20. Approximately eight and a half minutes into the test, smoke is no longer being blown out of the exhaust duct.

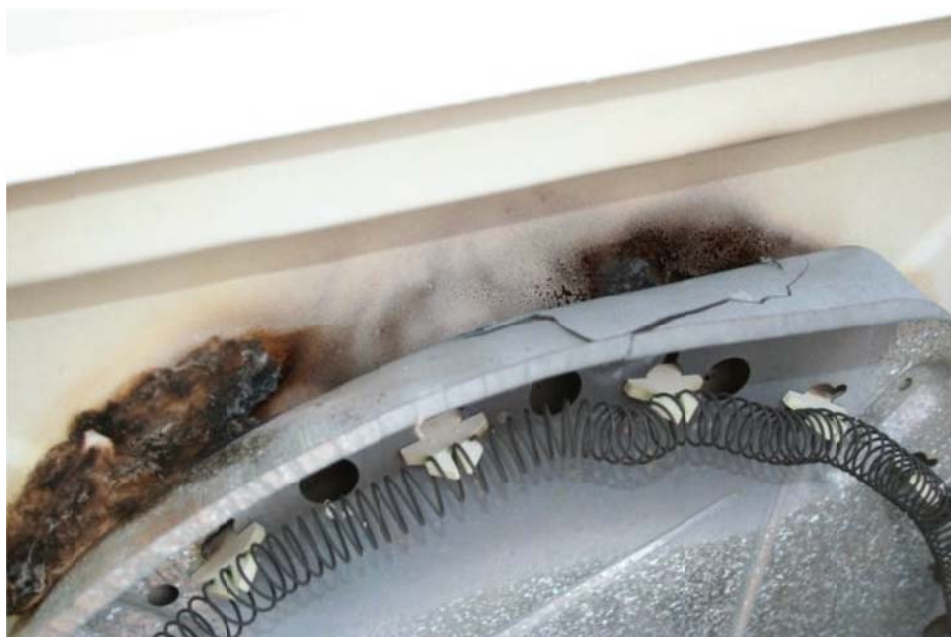
No photographs of the post fire state of the entire heater pan, baffle cabinet base, or front panel were provided. The top of the heater pan, showing consumption of the cotton balls and obvious residue is shown in Figure 23.

Figure 23. Area behind the heater pan after the fire test.

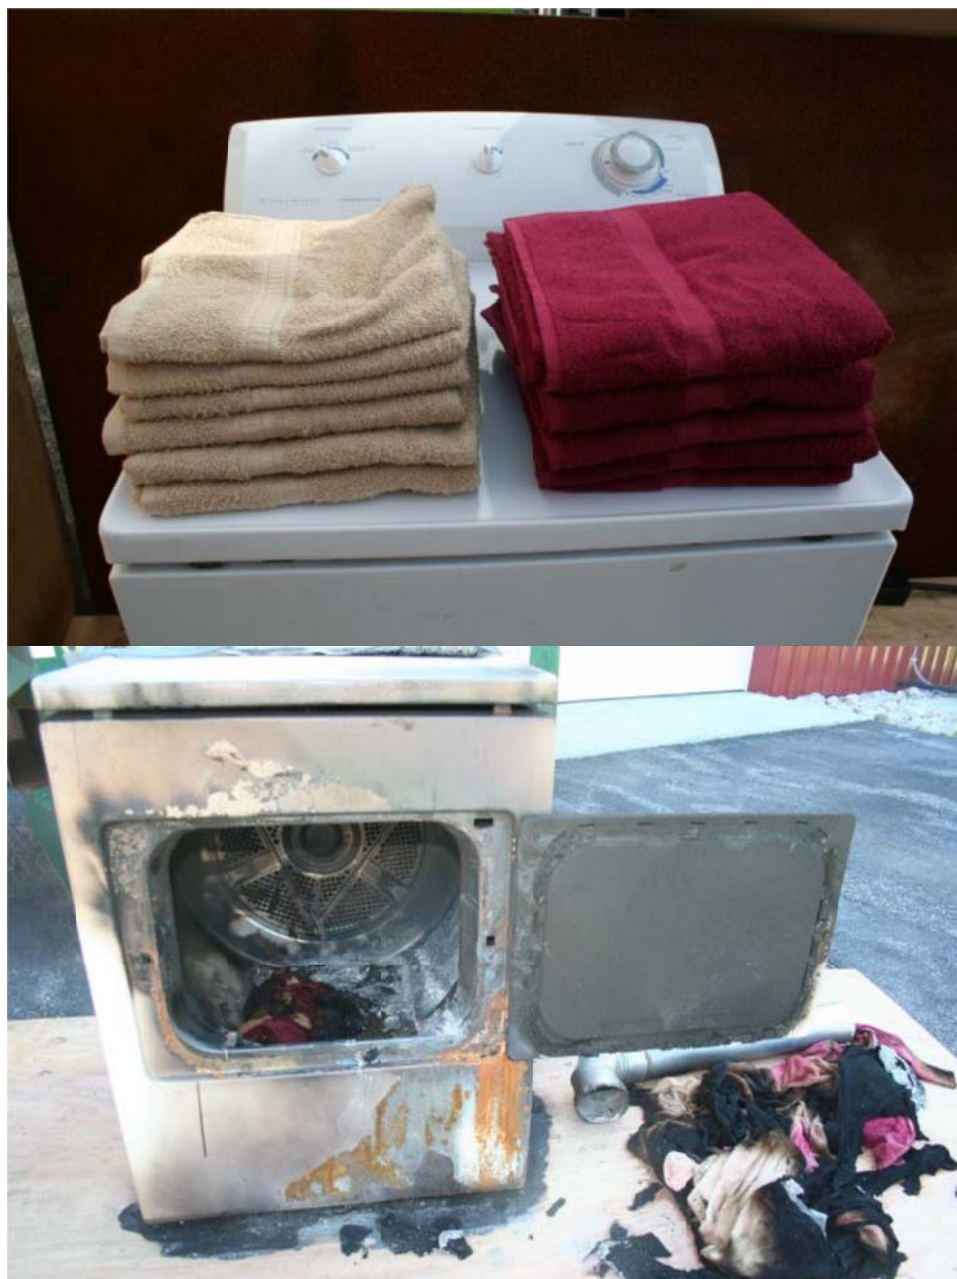
lint accumulation and combustion in this location. Nevertheless, the forced ignition of this cotton likely caused burning embers to be carried into the drum. The towel load was significantly involved and partly consumed as shown in Figure 24. Once the load was involved, it was able to spread the fire to the plastic air duct and blower after the blower ceased operating. If the downstream plastic air duct and blower had been ignited before the load, then discoloration of the paint in the lower right corner would be expected prior to the damage above the door. This progression supports the logical fire growth from the drum load then to other plastic components in the dryer.

Figure 24. Undamaged towels prior to the test and burned towels after the test.

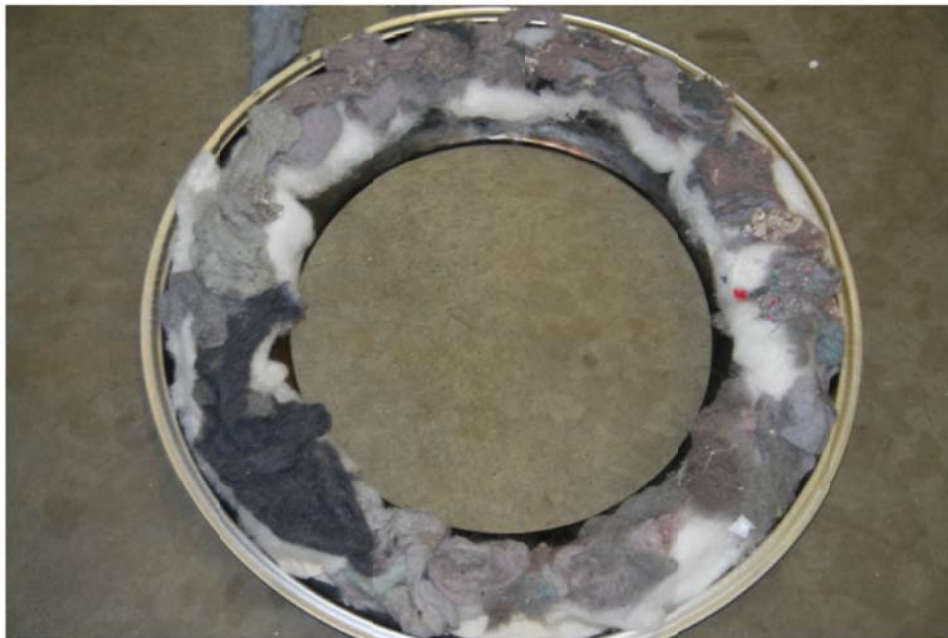
Image from Wright Group Hard Drive: \DRYERS DEPO INFO\Electrolux\Electrolux Testing\WGI & Traveler's_Electrolux_Dryer Testing Nov_Dec 2008\Test43_photo_1setup\photos pdf.pdf, IMG_1246.jpg

The Wright Group materials documented a series of 43 tests performed for Travelers Insurance in 2008. Again, an electric dryer was utilized for the test. Cotton batting, lint, and cotton balls were packed into the baffle, as shown in Figure 25, and placed on the bottom of the heater pan and on the ball-hitch. The exhaust was restricted by 50% and after turning the dryer on, additional masses of lint were dropped onto the heating element until ignition was achieved.

Figure 25. Lint and cotton packed into the baffle.

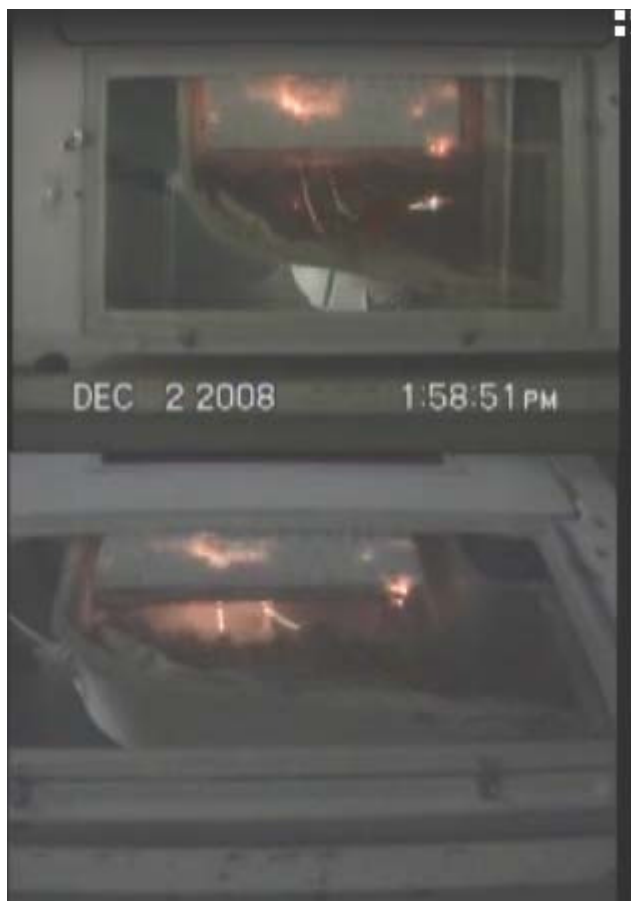
Video from Wright Group Hard Drive: \DRYERS DEPO INFO\Electrolux\Electrolux
Testing\WGI & Traveler's_Electrolux_Dryer Testing Nov_Dec 2008\Test43_video
Image exposure lightened

The fifth mass of lint dropped onto the heating element was able to ignite the lint packed into the baffle. Within a few seconds, this burning lint ignited the tumbling towel load. Approximately two minutes later, burning embers could be seen entering the air duct and flaming ignition of lint on the lint screen was observed as shown in Figure 26.

Figure 26. Sparks and burning lint in the air duct.

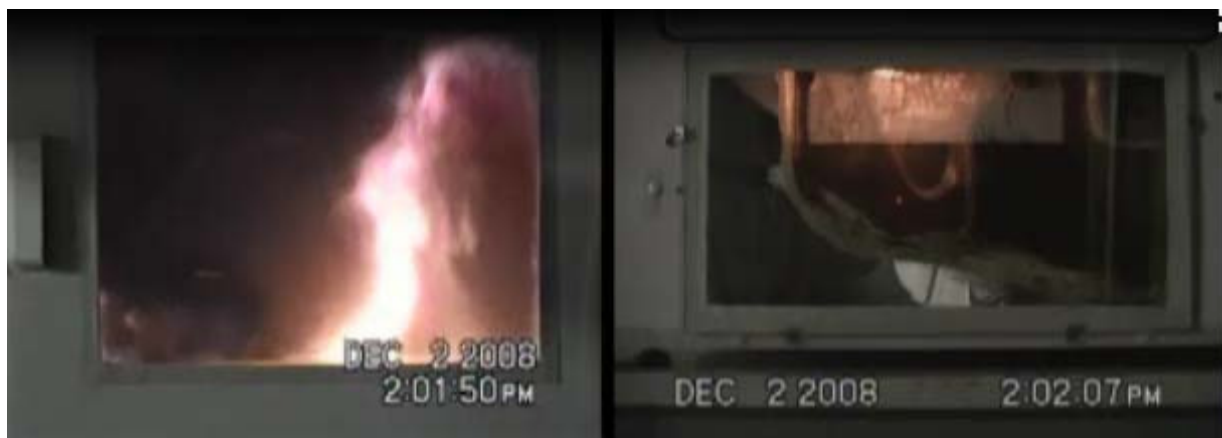
Video from Wright Group Hard Drive: \DRYERS DEPO INFO\Electrolux\Electrolux Testing\WGI & Traveler's_Electrolux_Dryer Testing Nov_Dec 2008\Test43_video

The paint above the drum door began to discolor approximately four minutes after fire initiation and one minute after the drum stopped turning. The drum load then burned for another one to two minutes before the plastic of the air grill began to melt and flow into the air duct and eventually onto the cabinet floor. Throughout this time, the lint in the air duct, the air duct itself, and the blower housing did not ignite (Figure 27).

Figure 27. Drum fire causing melted plastic of the air grill dripping into the air duct. Lint in the air duct is not ignited.

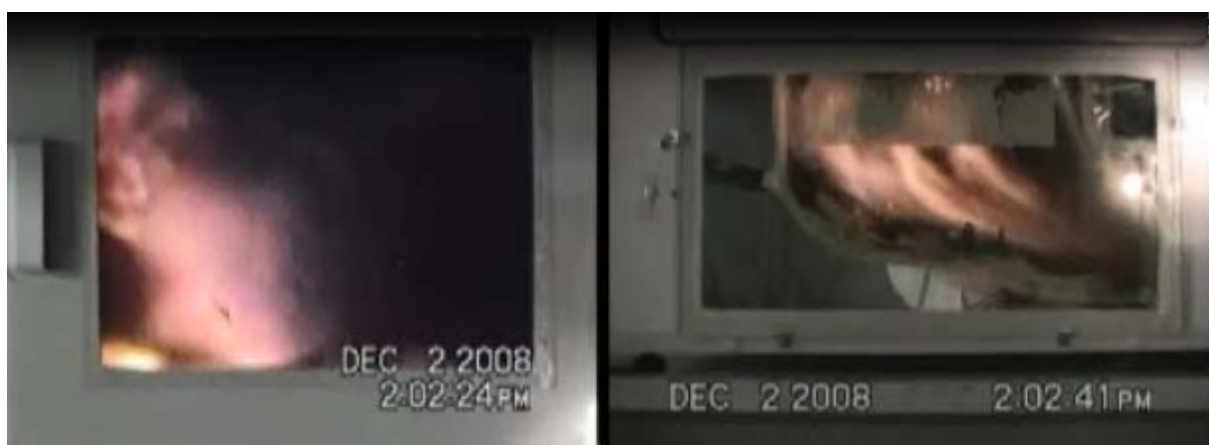
Video from Wright Group Hard Drive: \DRYERS DEPO INFO\Electrolux\Electrolux Testing\WGI & Traveler's_Electrolux_Dryer Testing Nov_Dec 2008\Test43_video

At approximately six minutes after fire ignition, the motor restarted causing the drum to turn and fire to be drawn into the air duct as shown in Figure 28.

Figure 28. Blower motor restarts and pulls drum fire into the air duct.

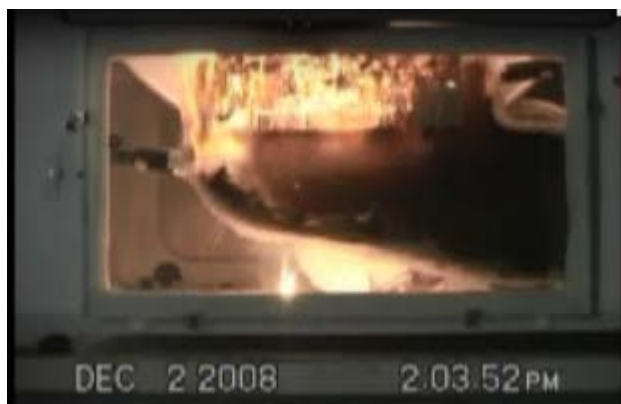
Video from Wright Group Hard Drive: \DRYERS DEPO INFO\Electrolux\Electrolux Testing\WGI & Traveler's_Electrolux_Dryer Testing Nov_Dec 2008\Test43_video

The blower continued to pull flames into the air duct for approximately 15 seconds after which the fire continued to burn in the drum, but no flames were observed in the air duct. After another minute, the fire began to burn down into the top portion of the duct. Fire was then observed on the base of the dryer as shown in Figure 29. Noticeably, the blower housing is damaged from the top down as the cabinet filled with the hot combustion gases from the burning load in the drum above. Eventually the entire air duct became involved in the fire. Over nine minutes after fire initiation, the bottom of the air duct began to melt and sag to the bottom of the dryer cabinet. The drum door was opened, and the fire was extinguished 11 minutes after ignition.

Figure 29. Flames visible in the top portion of the air duct and in the base of the dryer.

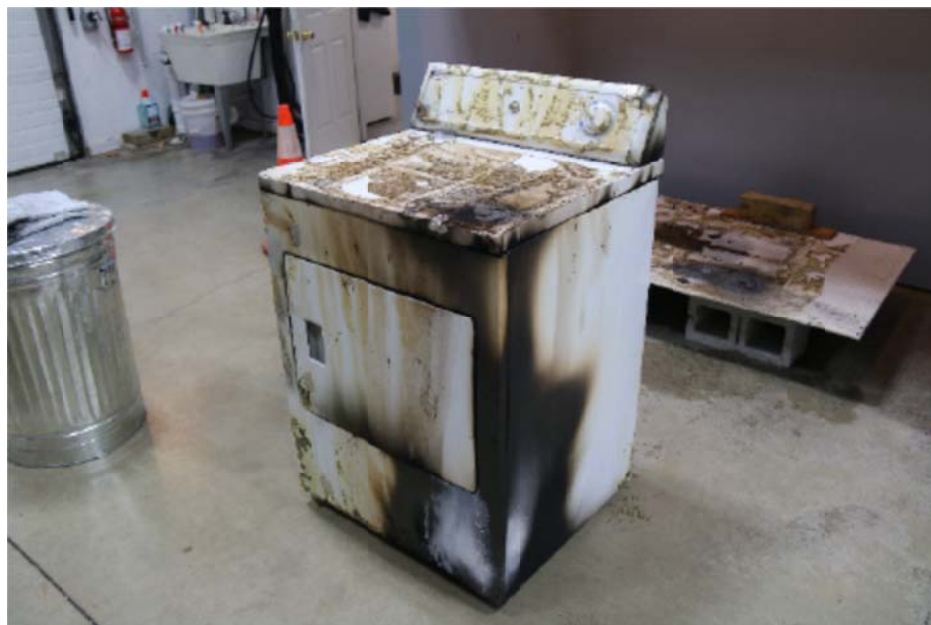
Image 250 from "Burn Test 01_10-31-2013.pdf"

from the cabinet during the test. The external and internal fire patterns are consistent with patterns on fire-involved dryers that have an overall similar level of damage (see Figure 30).

Figure 30. Exterior fire patterns are identical to fire damage patterns observed to most Electrolux ball-hitch dryers that have been involved in a fire incident.
